PHOTOGRAPHIC INTERPRETATION REPORT

VITAL RECORDS COPY
RECENT CHANGES AT
PEI-CHING GUIDED MISSILE
DEVELOPMENT AND
PRODUCTION CENTER
CHANG-HSIN-TIEN, CHINA

FEBRUARY 1967

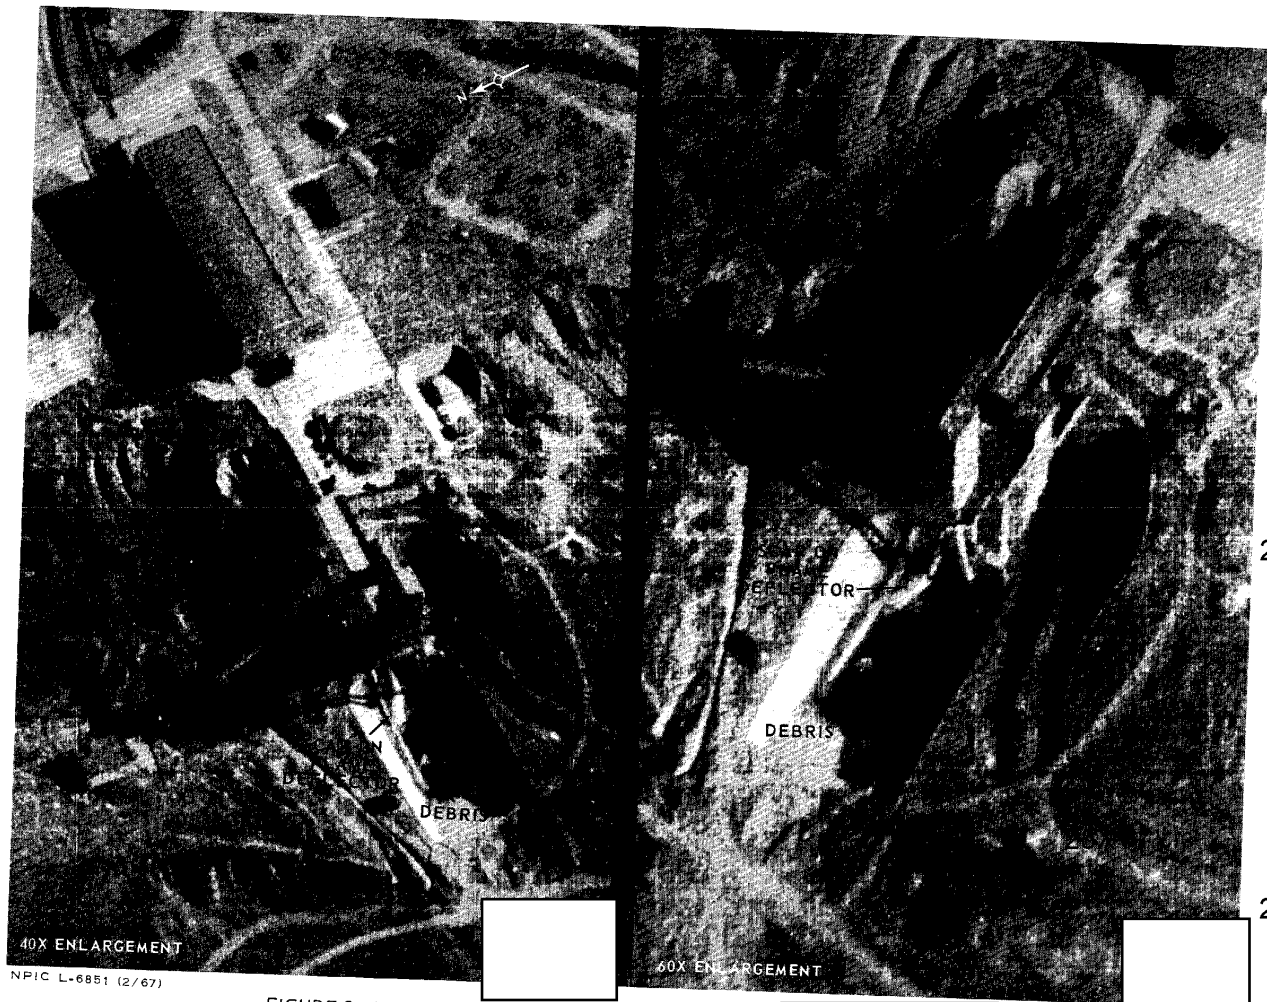
FIGURE 3. TWO VIEWS OF TEST STAND NO 3, PGMDPC.

Evidence of recent test activity is visible at Test Stand No 3, the largest stand in the Rocket Engine Test Facility at the PGMDPC: 2 oblique views of this test stand are presented in Figure 3. A fan-shaped scar is visible on the lower part of the flame deflector, and a narrow scar or fissure is apparent on the upper part of the flame deflector which extends up under the test stand superstructure. The sump has been drained of most of the large volume of effluent observed on photography of [REDACTED] 1/ and debris is visible in the bottom of the sump. This debris appears to consist of a large curved object and a

smaller object; however, this debris could possibly be sediment of some type. The debris was not present on [REDACTED] 1/ The outline of the easternmost corner of the bottom of the sump also appears to be somewhat disrupted, as if a slide had occurred or an excavation is in progress. The northernmost of the 2 superstructure support struts appears thinner than when seen on [REDACTED] even though the shadows of both support struts are about the same width. All these factors possibly indicate a minor accident at this test stand, an accident of the type that could be expected to occur occasionally when a large rocket engine is test fired.

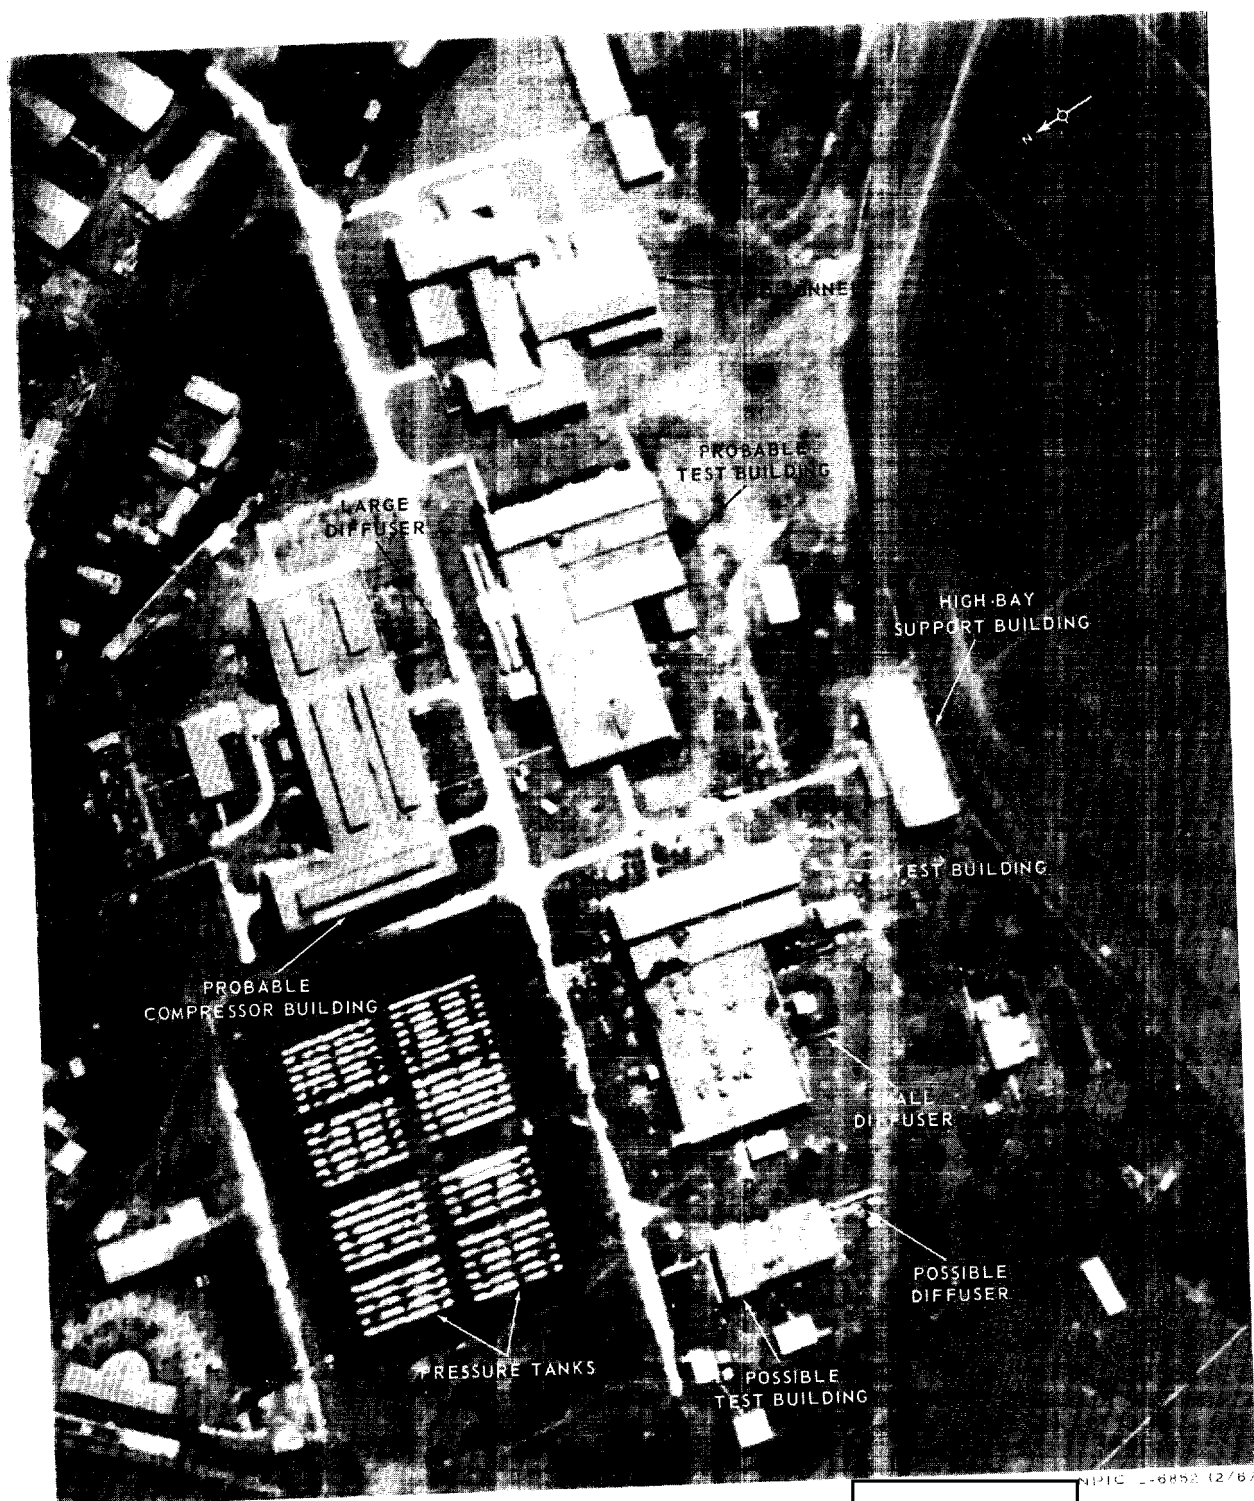
FIGURE 4. RESEARCH AND DEVELOPMENT AREA

The Research and Development Area contains a previously identified wind tunnel of the continuous-flow, closed-circuit type, an adjacent probable test building, a probable compressor test building, and a group of horizontal pressure tanks (Figure 4). The [REDACTED] photography reveals a large and a small diffuser extending from the south side of a test building previously identified as a probable test building (Figure 5). The presence of the 2 diffusers indicates that the building contains at least 2 high-velocity wind tunnel test units. The large diffuser was first observed in a storage yard on photography of [REDACTED] and near the probable test building on [REDACTED] pho-

tography. 1/ A nearby small building with 1 possible diffuser is newly identified as a possible test building.

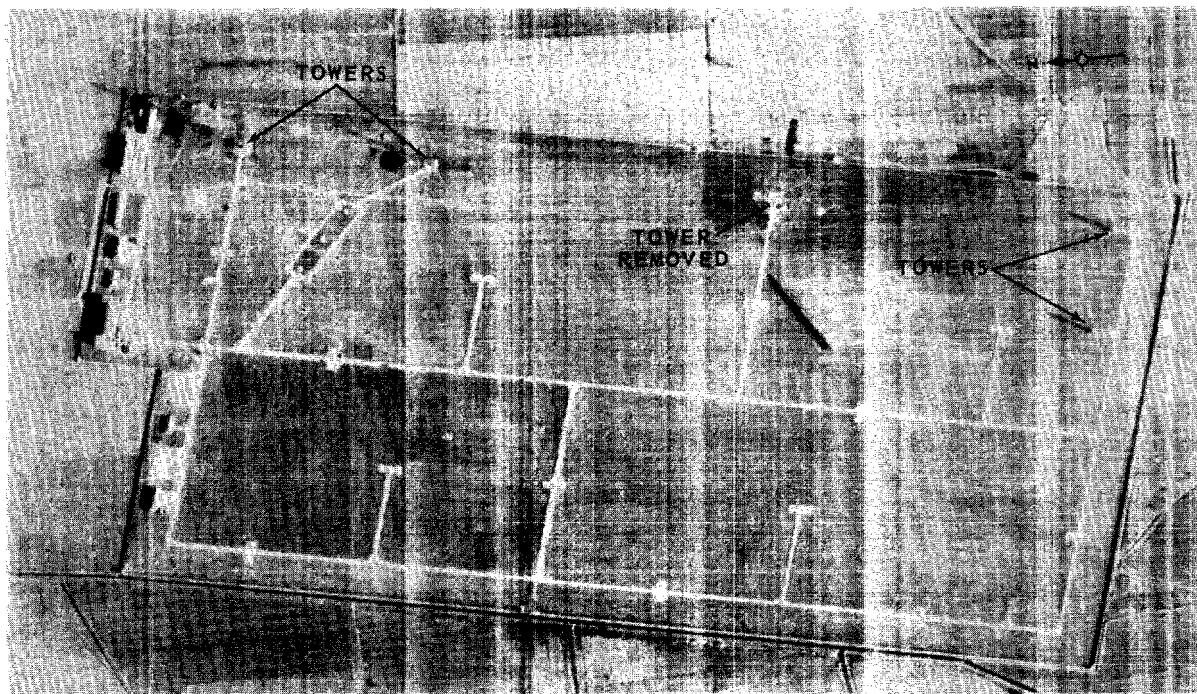
FIGURE 6. RECTANGULAR SECURED AREA, [REDACTED]

been removed from the Rectangular Secured Area which is located about 1 nm southeast of the Research and Development Area (Figure 6). The [] photography reveals that the thermal powerplant is in operation. Sixteen rail/tank cars and considerable amounts of material in open storage are visible throughout the center, although few vehicles can be seen.
